Head of the Executive Committee of Historic Cairo Development Project ABDEL-SALAM, Farouq B.A.

Supervisor of
Historic Cairo Development Project
ABDEL-MONEIM, `Ayman B.A., Egyptologist

Authors

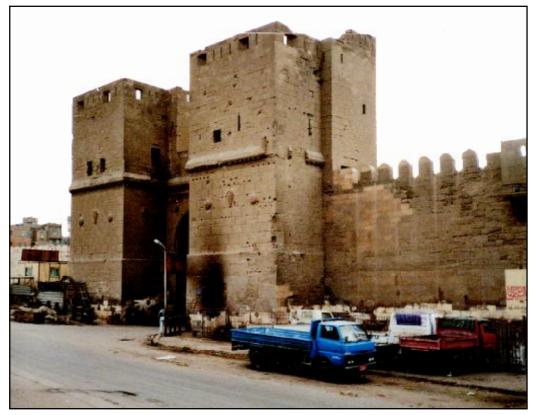
التدهور المعماري الحادث في باب النصر والناتج عن ارتفاع مياه الرشح في الحوائط والتلوث الناتج عن الاستخدامات المحيطة بالأثر. $The architectural deterioration of Λn-Nasr Gate due to the increase of water in walls and the pollution resulted from the different activities around the monuments.$

The restoration process of the monument passed through many stages. The ports were first repaired and the depleted stones were changed. All the foundations were structurally reinforced and all the elements of the port received similar fortification. Furthermore, the different phases through which the ports have passed were documented. The effect of the temperature and moisture was measured and all the observations were recorded. In view of such studies, the restoration project proceeded. The wooden elements were repaired and the lost parts were supplemented. Iron rust was also treated, and the material was analyzed so as to complement the iron parts according to the monumental origin. Glass fiber was used to fill the gaps spread between the monumental elements and the newly added parts. The ports were also dissembled to treat their arms. They were then re-installed in a way that grants them much flexibility of movement.

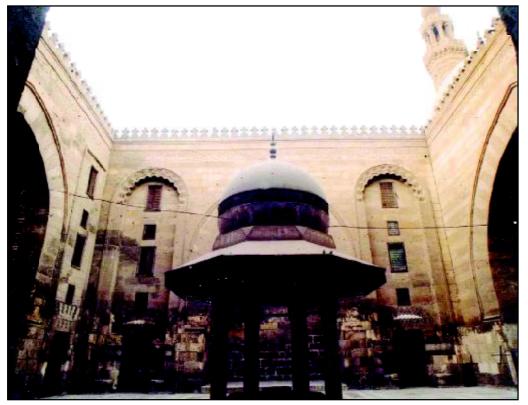
صحن المدرسة ويظهر به تدهور حالة الأحجار

The conservation project aimed primarily at ensuring the structural safety of the building. The wide crack was grouted and the original stones were repaired. The inner masonry core was also grouted, and the wooden ceilings were restored. Furthermore, the water-supply network serving the ablution area was renewed.

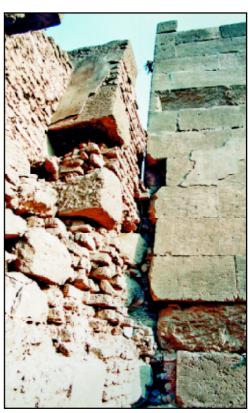
تدهور إنشائي للعناصر المعمارية للمدرسة

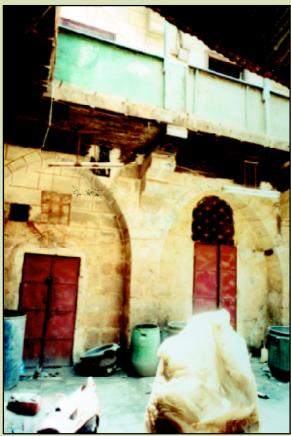
Deteriorated condition of the salm before restoration

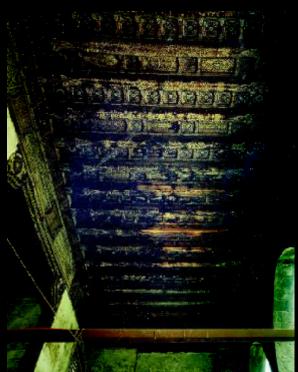
The decorative ceiling of the Megaad before restoration

Furthermore, a relieving ceiling was added to the maq`ad so as to increase the structural capacity of its original ceiling. Cracks were then repaired and the damaged wooden beams of the mihrab ceiling were changed. All the ceilings that were structurally unsafe were supplemented with relieving ceilings. In facing the effect of the moisture, the walls were injected with a silicon material so as the halt the water which rose in the walls through the capillary action. All wooden elements were then repaired and treated against fungi. The stones, especially those which were badly affected by the moisture, were overhauled: and the store rooms which lie under the mag'ad, were reinforced and injected. Finally, three layers of plaster were done with a mixture that suits moist places.

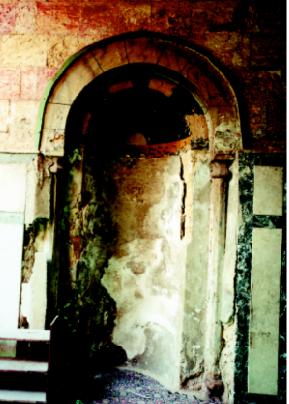
تدهور حالة الأحجار بالمعراب الخارجي Deteriorated condition of stones and the external milurab

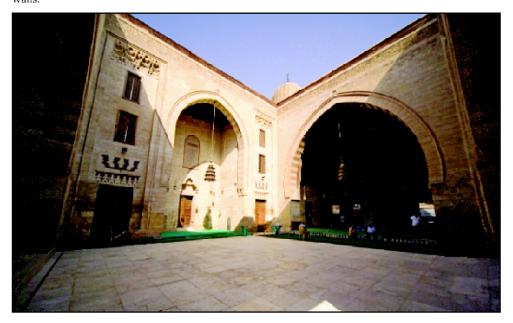
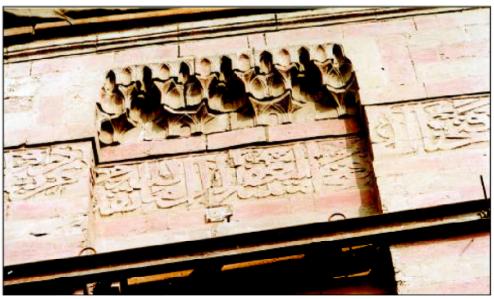
Elements of the Building before restoration

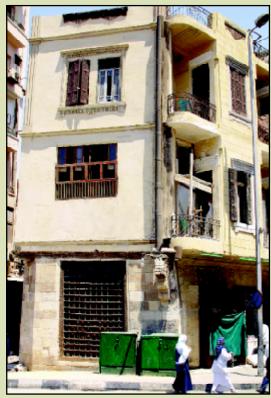
Façade of the Sabil overlooking al-Azhar street

At the onset of the restoration project, the underground cistern was discovered. It lay under the cracked and damaged marble floor, and the cistern was uncovered in the course of the conservation of that floor. The cistern is composed of a large space with two domes: one of them lies under the space of the sabil, and the other under the space of the staircase leading to the kuttab. The sorry state of the cistern was among the major factors threatening the safety of the sabil and the kuttab. Structural consultants were thus of the opinion that it was necessary to fill the cistern with clean sand so as to equate the pressure caused by the loads of the soil. Furthermore, the masonry of the walls of the sabil and the kuttab was pinned using wooden beams, and it was grouted with a mortar compatible with the original mortar. All traces of modern cement plaster were removed and the walls were plastered with a plaster mix compatible with the old plaster.

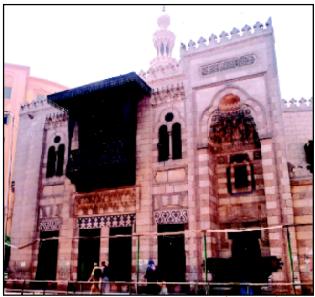
A crack in the façade واجهة شارع الأزهر قبل البدء في الأعمال overlooking Al Azhar street

In the first stage of the preservation process, the ground floor of the masjid and the depots were discovered. The domes under the nave were repaired, and wooden beams were installed to transfer the nave loads to the walls. Such walls were injected, so as to reinforce their structural potency and the roofs were insulated. Furthermore, all the elements of the monument including the doors, the copper and wooden windows ...etc were overhauled, and the worn out stones of the frontages were changed.

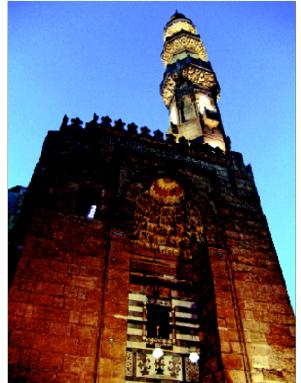
المدخل الرئيسي بعد الترميم The main entrance after restoration

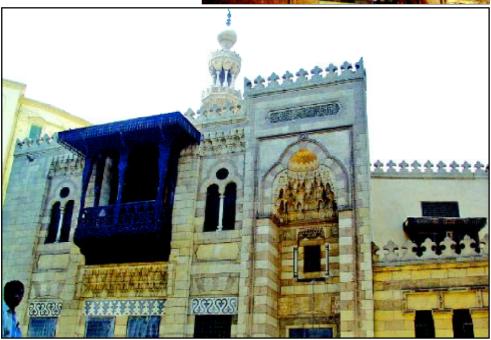
The façade overlooking Al Azhar street after restoration

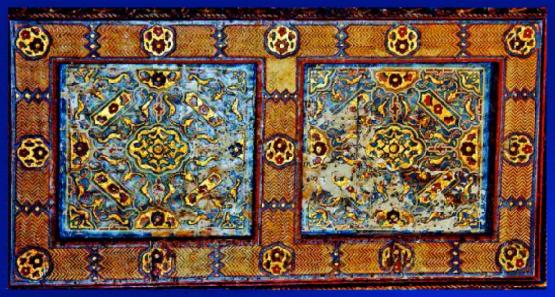
سقف السدلة الشمالية الشرقية بعد الترميم

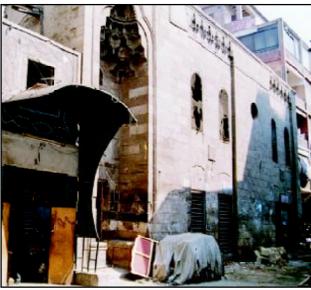
The mosque façade before restoration

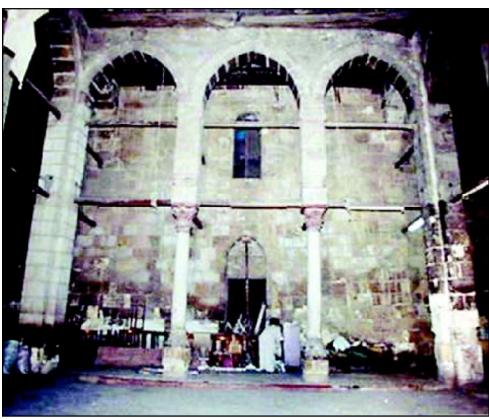
The internal Salm of the mosque and the deteriorated condition of its stones

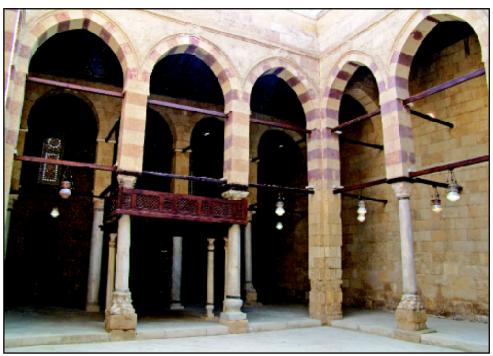
The Qibla lwan and its columns after restoration

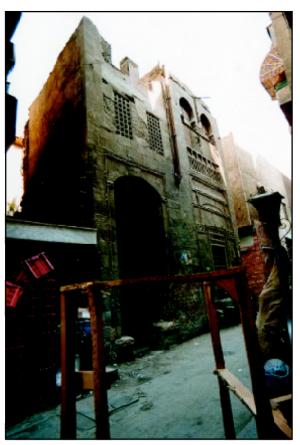
infested with cracks, and the northwestern wall in particular suffered from a major vertical crack. The most hazardous of such cracks was the one that penetrated the main foundation pier that carries the

صور توضح حالات التدهور في مبنى السبيل والكتاب قبل الترميم ما بين تدهور إنشائي وسوء استخدام $An \ illustration \ for \ the \ deteriorated \ condition \ of \ the \ sabil \ and \ Kuttab \ before \ restoration \ either \ due \ to \ constructional \ deterioration \ or \ misuse$

The restoration policy was to achieve structural safety and to repair all the debilitated parts. The aim was to bring into view the artistic as well as the historical value of the monument. After conducting many studies on the monument, the cracks were injected and the inner core was strengthened by grouting.

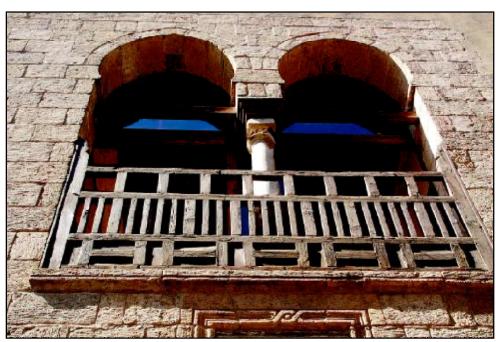
The façade after restoration

بدات أعمال الحفاظ بحقن الحشوات لتقويتها وتزرير الشروخ بالدبل الخشبية وبالحقن علاوة على إزالة الإضافات المستحدثة الضارة بالأثر وتم ترميم كافة العناصر الخشبية كما تم تدعيم أعتاب الشبابيك وترميم الواجهات الرئي Accordingly, the masonry core was grouted, and the cracks were injected and pinned using wooden lateral beams. All the modern additions, which had had an adverse effect on the monument, were removed, and all the wooden

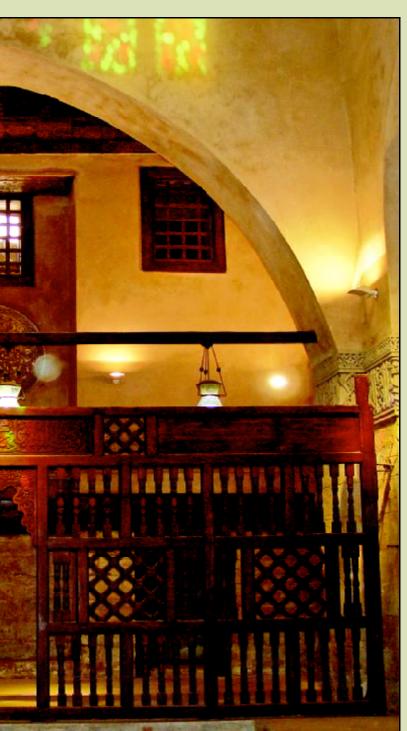
إيوان الصلاة بعد الترميم The prayer Iwan after restoration

The restoration process passed through many stages. The cracks were first pinned using wooden beams. The walls were grouted, the foundations were consolidated, and the stone and the wooden elements were restored. Walls which were structurally unstable were dismantled and rebuilt. Furthermore, all modern plaster was removed and replaced by new plaster similar in color and composition to the original plaster.

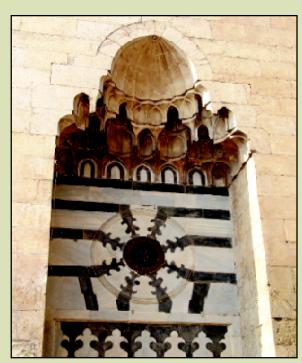
مقرنص المدخل بعد أعمال الترميم Stalactites of the main entrance after restoration

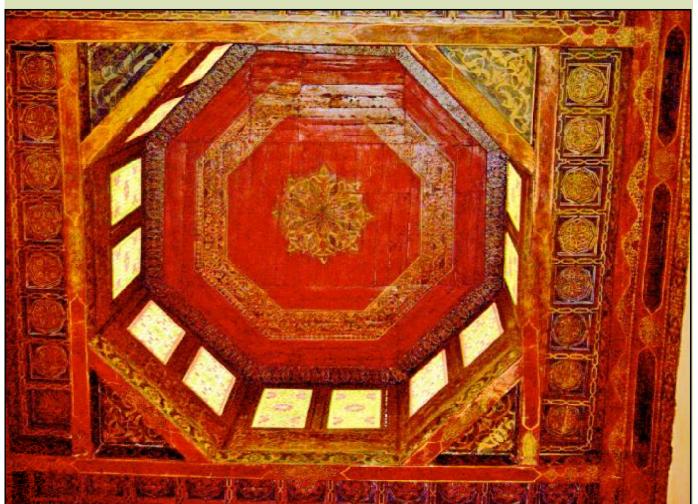
شخشيخة المسجد المزخرفة بعد أعمال الترميم The Decorative Shukhshaykha after restoration

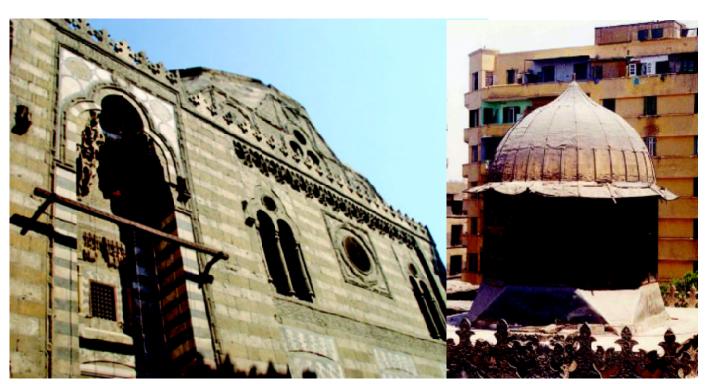
الواجهة الرئيسية على شارع المعز قبل الترميم The main entrance overlooking Al Mu'iz street before restoration

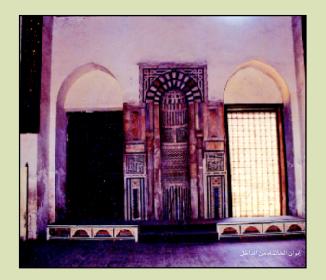
تدهور البراطيم الحاملة لقبة الخانفاء Deterioration of the wooden beams carrying the dome of the Khanqah

After lengthy discussions, it was decided that the concrete ceiling of the Dome must be replaced by a wooden ceiling made up of twelve wooden beams bound together by ametal ring. All the elements of the khanaqa were restored, and all the

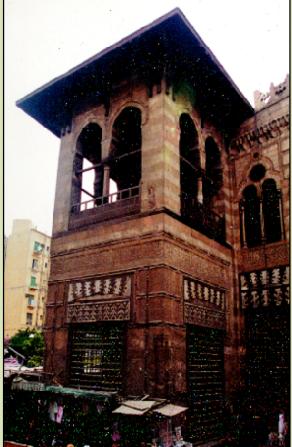
$Deteriorated\ condition\ of\ the\ Sabil\ entrance$

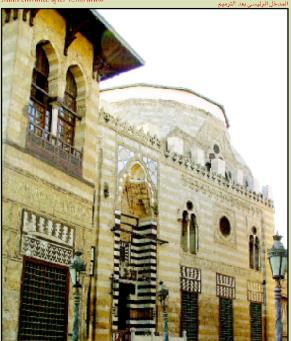
Main entrance after restoration

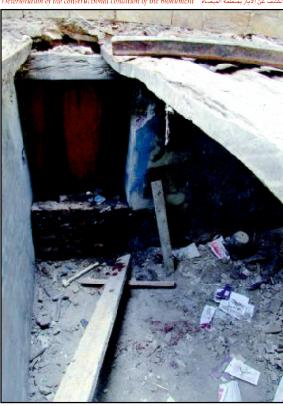
walls of the sabil before restoration

It is noteworthy that the two floors of the tekkia which were built above the monumental sabiil and Hawd have doubled the loads which they carry. This in turn increased the pressure on the sabiil walls and led to their bents. In the aftermath of the 1992 earthquake, the sabiil was separated from the tekkia leading to horrible cracks on the walls. Furthermore, the high rate of moisture resulted in the calcinations of salts.

Following such studies, the project team decided to build structural partitions between the sabiil and the hawd from the tekkia. The walls were also reinforced, and the cracks were overhauled by injection. Furthermore, all the wooden elements and the ceiling were restored, and the painting was completed with a mixture that corresponds to the original concoction, the constituents of which were identified by analysis.

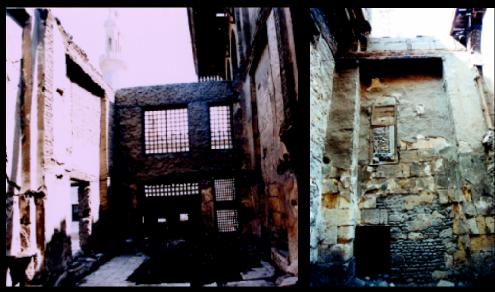
The collapsed upper Qa'a

During the first stage of the conservation process, the foundations were examined and restored; and the damaged masonry blocks were replaced by new ones. Those foundations were also grouted with a lime-based mortar to strengthen them. All modern plaster was removed from the walls and the cracks were pinned using wooden beams. The back hall, on the other hand, was reconstructed according to its original design as gleaned from the historical sources. The vertical connecting passage was also restored and the damaged floors were replaced by new ones. The cistern was discovered as well and was reinforced. It was in good condition and had a square shaped plan with a central pillar.

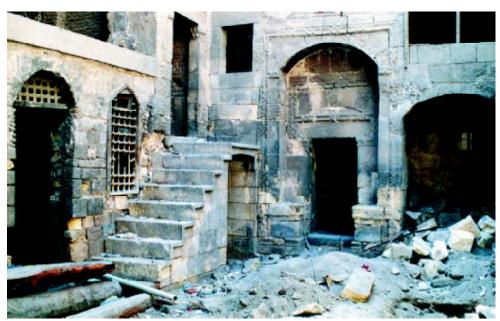
This monument suffered many structural problems, some a direct result of the modern construction adjacent to it. The construction of the latter led to the collapse of some walls and to the appearance of cracks in others. The house also lost many of its original components, and the ceilings were in an extreme state of decay. For more than one hundred years, the house was neither maintained nor restored.

The house before restoration

building was structurally consolidated. Most of the cracks were pinned. Relieving ceilings were constructed above the deteriorated old ceilings, thereby reducing the loads they bear, while conserving the old fabric and its decoration. The original level of the alley leading to the building was uncovered, and the urban surrounding was replanned and the streetscape redesigned in light of the final post-conservation appearance of the building.

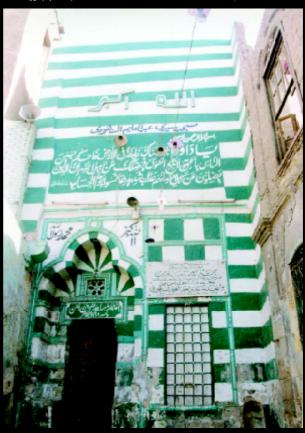
Ahmad Shaíbanís zawiya gained its importance from the religious and the social role it played for the residents of the neighbourhood. People were attached to the place, so much so that they contributed to its restoration and renovation. Unfortunately, such interventions adversely affected the mosque, which lost much of its original fabric. Indeed, the new repairs concealed much of the original elements of the monument and and introduced new elements such as the concrete roof above the prayer area. Other negative interventions included the changes done to the ablutions room and the construction of new toilets. The wooden ceilings, on the other hand, were in a terrible condition, because of the leakage of rainwater.

Ahmad Ibn Sha'baan Zawyya before restoration and its several problems

قبل البدء في الأعمال تم الكشف عن عناصر المبنى الأصلية لتحديد شكله الأصلي فتم الكشف عن الصهريج وتنظيفه كما تم تدعيم الأساسات وحقن الحشوة لتقويتها وازالة جميع الإضافات المستحدثة بالمسجد وإعادته إلى وضعه الأصلي. Prior to embarking on the restoration works, it was essential to identify the original elements of the building, and to visualize its original design. First, the cistern was found and cleaned. The foundations were then reinforced, and the masonry core was grouted. All the new additions were removed and the mosque was restored to its original condition.

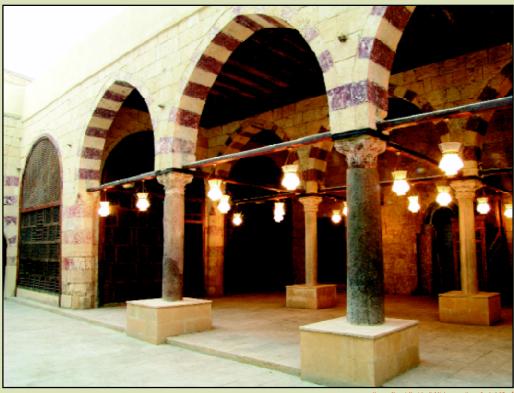
Aisles after restoration and removal of the concrete ceiling of the court

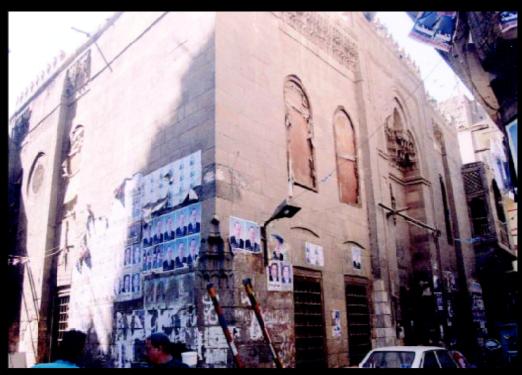
$External\ façades\ before\ restoration$

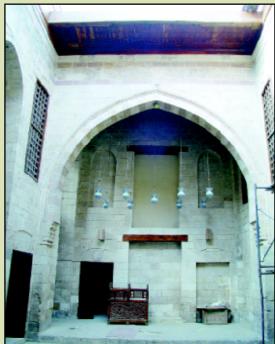
The Iwan opposite to the Qibla Iwan after restoration

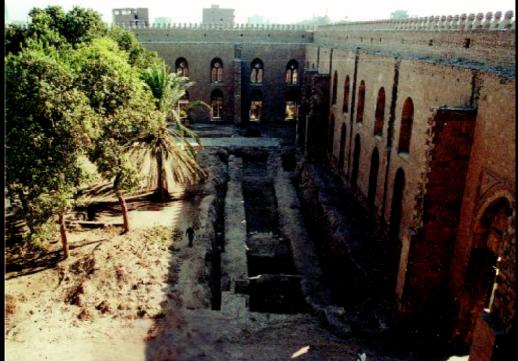
$Excavations\ that\ \ detected\ the\ mosque\ foundations$

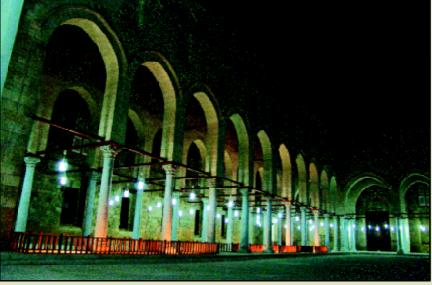
الجزء المكتشف من السور الجنوبي بعد الترميم Excuvated part of the southern wall after restoration

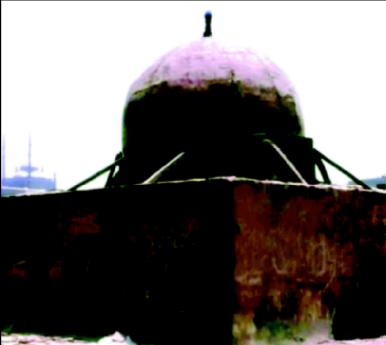
شرخ في سقف المسجد الخرساني A crack in the concrete ceiling of the mosque

Fissures apparent in the aktaf and 'ugoud were overhauled with braces and wooden piers; and the effects of the moisture were treated by walls injection. The newly added tiles were removed, and the cracks of the concrete ceiling were fastened with iron clips which are 13 mm in diameter. The cracks were also injected with a strong mixture. As for the floors and dikkas, they were insulated, and the original ones were restored. Furthermore, a drainage course for the rain was extended. The restoration of the wooden and the stucco elements was undoubtedly a rare artistic epic in which the international as well as the Egyptian expertise was employed to save such elements. Finally, such epic culminated in the restoration of the sole remaining monument that belonged to the city of Al-Qata'e'.

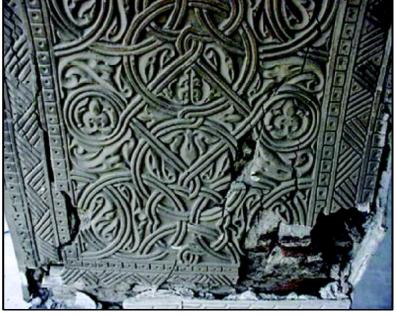
Deterioration and effacement of plaster ornaments

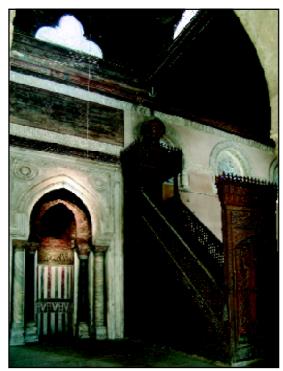
The mosque mihrab and pulpit after restoration محراب الجامع والمنبر بعد الترميم The mosque mihrab and pulpit after restoration

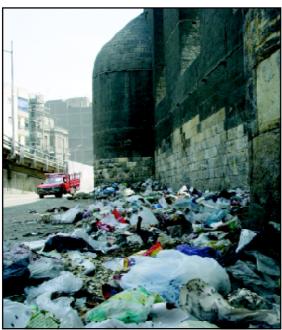
Rubbish of the neighbor houses

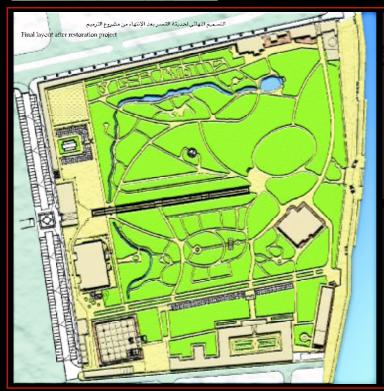
- The palace garden had suffered for a long time from the unauthorized buildings such as the hotels and the cabanas which led to its deterioration.
- Deterioration of the infrastructure led to a severe water leakage that terribly damaged plants and architectural elements in the garden and the enclosure wall.
- Unauthorized and intruder buildings caused visual malformation in the garden.
- Intensive studies were executed to discover the original appearance of the garden during the time of the prince and consequently new buildings were removed.
- Work in the garden based on two axes: First was a comprehensive gardening for trees and green spaces and the second was to recapture the original imprint of the garden and to make a thorough fixing for the deteriorated infrastructure.

Bad condition of the palace garden مبنى العاملين بالفندق

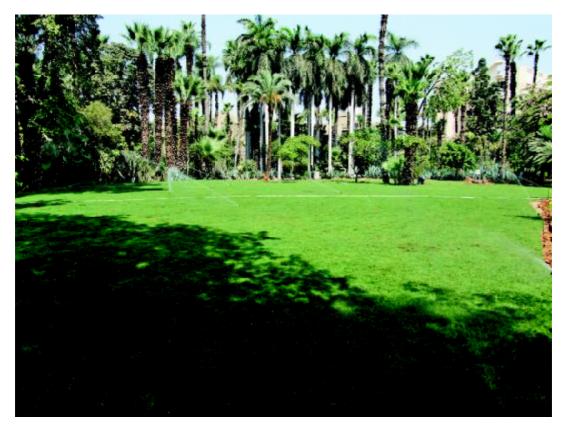
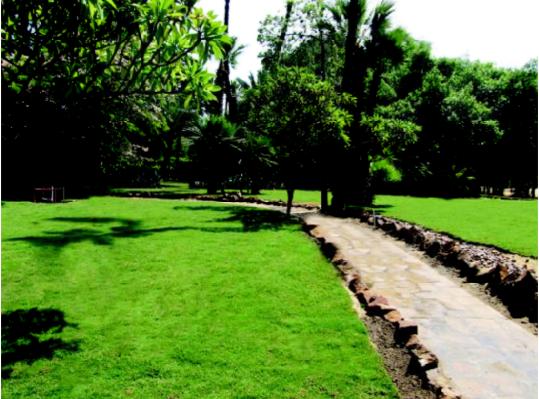
Palace garden after restoration

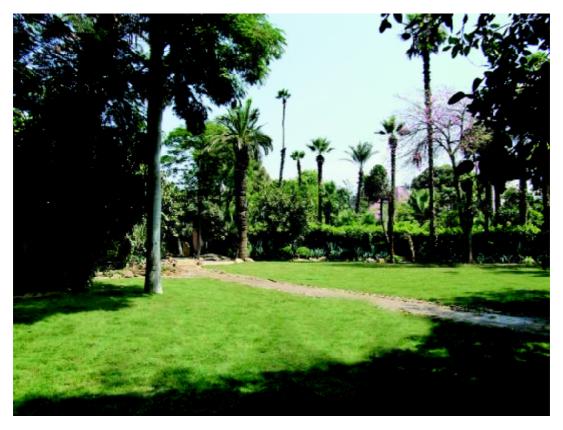
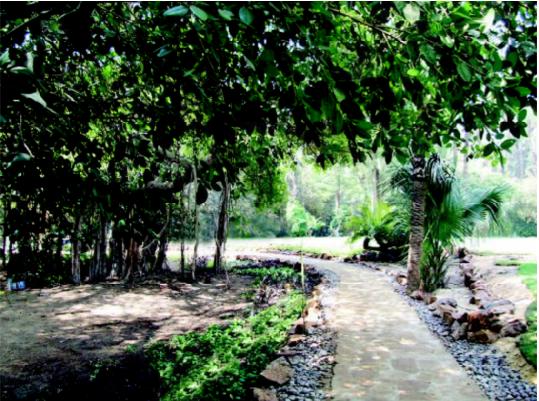
Palace garden after restoration

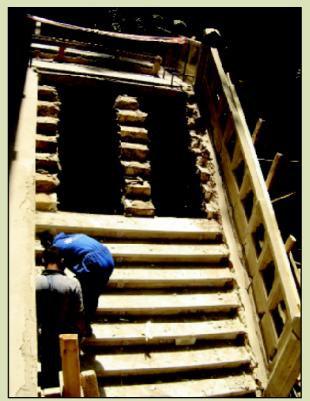
- Different cracks spread in the walls, the ornaments were in a bad condition but this, actually, had never disclosed the real
- never disclosed the real deteriorated condition.

The golden hall was about to collapse because this huge hall was based on a semi-fallen basement, full of cracks and the iron of its ceiling and the pillar was eroded.

Foundations condition deteriorated, water leaked from the surface and the result was the dismantle of the ornamented tiles in the ceiling.
- in the ceiling.

Deterioration aspects in the hall

- Basement of the hall was constructionally consolidated by metal skeleton and the pillars found in the middle of the hall were removed.
- Side pillars were consolidated an the iron was treated by anticorrosion materials.
- Metal skeletons created spaces used as the most modern museological storage that convoy the requirements of the grand museums.
- Crakes of the walls were treated and the separated tiles were refixed.
- The effaced ornaments of the hall regained its shining and this resulted in the highlighting if the most wonderful styles in the *shamia* hall.
- Temperature control system was executed to prevent it variation along the day.
- Work was ended by restoring the ornaments, wood, treatment of the surface and domes, insulation and deviations to drain rainwater.

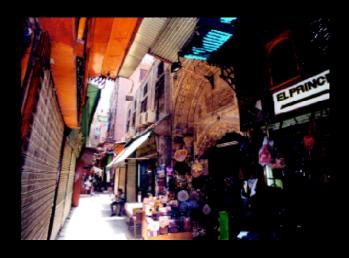
The architectural structure was badly affected and disfigured by incongruous additions made by squatters to expand the area of their stores. In the course of their miscalculated expansion works, the squatters eliminated walls, disturbing the balance of the entire structure. The new interventions also led to the water seepage from drainage network. Worse, a number of lintels broke off; and cracks developed alarmingly across the walls and vaulted ceilings of the stores. The original floors disappeared. Different parts of the eaves topping the main passage collapsed under the heavy load of new floors. In addition, the seepage of rainwater caused the decay of wooden ceilings.

بدأت أعمال الترميم بإزالة آثار استحداثات السكان وتحرير ممر الحركة الرئيسي كما تم عمل تدعيم كامل وتزرير شروخ الحوائط بالدور الأرضي بإرجاعها إلى أصلها الأثرى وإعادة بناء الحوائط المزالة وتربيط الاكتاف المنفصلة عن الواجهة الرئيسية بالدبل الخشبية علاوة على فك بعض الأسقف المقبية الغير آمنة إنشائياً وإعادة بنائها وترميم البعض الآخر عن طريق الفك المرحلي من أسفل في الحالات الأكثر اتزاناً ، مع ترميم المظلة الخشبية وإزالة الأحمال الزائدة كما تم عمل طبقات تخفيف أعلى قبوات الدور الأرضى أو فروق مناسيب لتلافي الأحمال الزائدة . وتم معالجة آثار النشع في الحوائط وانتشار الأملاح بها وترميم كافة العناصر الخشبية التي تم فيها الكشف عن الألوان الأصلية بالإضافة إلى استكمال البياض بمونة متوافقة مع المونة الأثرية وكما تم علاج الأسقف الخشبية بالوكالة وعمل عزل وميول لصرف الأمطار بها.

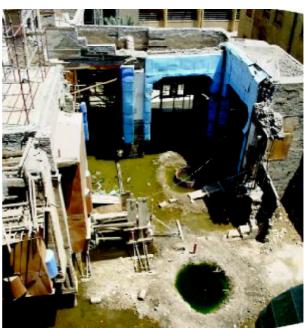
تدهور الحلة الإنشائية والمعمارية لحوائط وعناصر المبنى من آخشاب وآحجار . Deterioration of the constructional and architectural condition of the walls, wooden elements and stones.

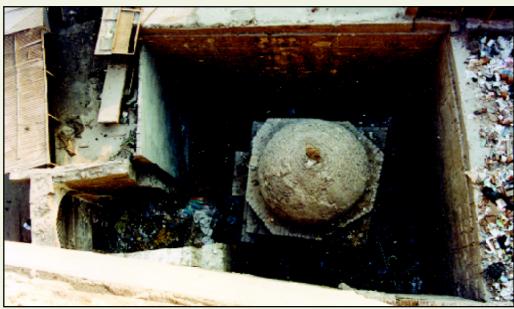
Accumulation of wastes around the dome

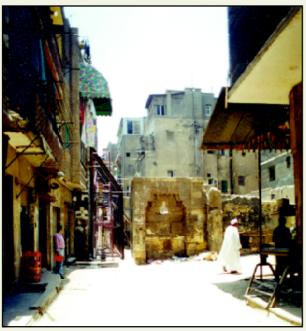
Loss of the wooden ceiling

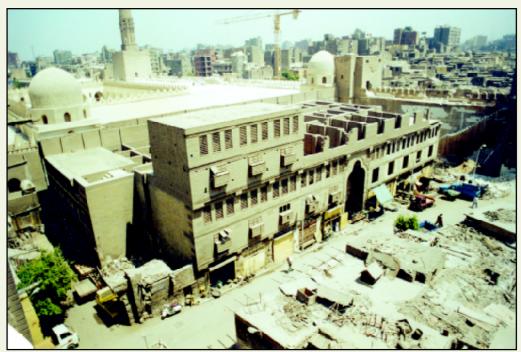
A photo illustrates the loss of the upper floor of the Wekala

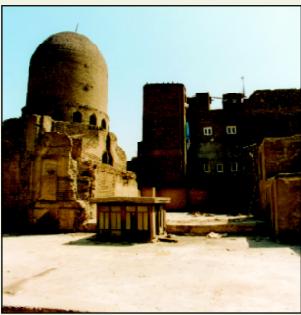
Deterioration of building materials of the dome

تدهور حالة مواد البناء بالقبة
